2026 Quinquennial Review Christ the King Church & Porch House

SUMMARY OF JOBS

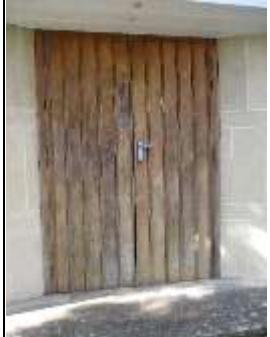
Location: C3

Description:	Doors need protective covering. Suggested removal of beading and covering with pvc panel and then replacement of beading.
Urgency:	Medium term (2026-7)
Possible cost?	Inhouse
Progress?	The steps have benefitted from drier weather. A treatment for the algae that is growing on the steps has been applied and the steps will soon be pressure washed. As this entrance is also an emergency exit, thought is being given to the possibility of a safety handrail and level access. (GH 5/25)

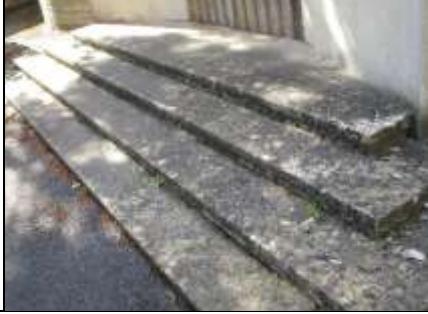
Location: C4

Description:	Steps need power wash and then fitting of safety strip as used as fire exit from church. Consider construction of ramp on left-hand side to provide access for disabled.
Urgency:	Medium term (2026-7)
Possible cost?	Inhouse
Progress?

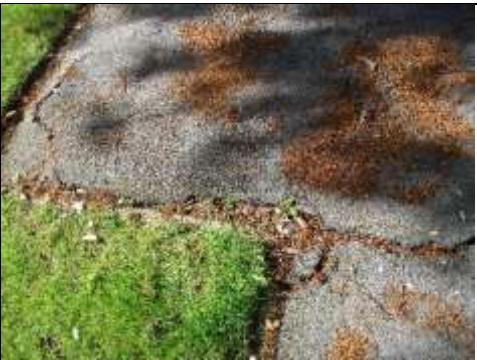
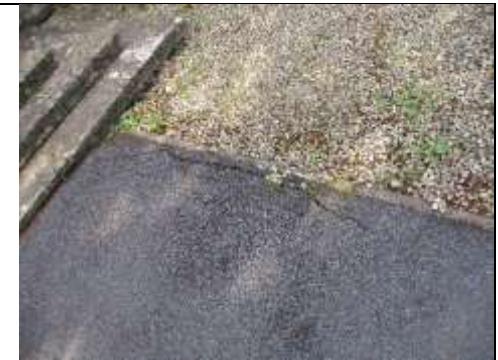
<p><i>Location: C6</i></p> <p>Former Church entrance – Tarmac area in front of former entrance to church</p>

<p><i>Description:</i></p>	<p>Roots of large fir tree in front garden now lifting tarmac with risk of injury and damage to steps up to church door. Need to seek advice on cutting of trunk.</p>		
<p><i>Urgency:</i></p>	<p>Medium term (2026-7)</p>		
<p><i>Possible cost?</i></p>		<p>Contractor if tree-cutting advised.</p>	
<p><i>Progress?</i></p>

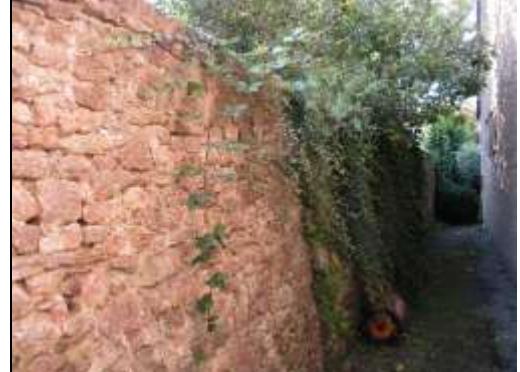
<p>Location: C8</p> <p>Boundary wall along side of church</p>

Description:	Old wall with extensive plant growth showing signs of damage and movement. Need to establish ownership and responsibility for wall. Plant growth needs removal and condition of wall examined. Stonework needs examining around all boundary wall.
Urgency:	Short/Medium term (2025-7)
Possible cost?	Contractor
Progress?	All the boundary walls have been examined by and advice taken from Tony, a local ancient wall expert. Tony has now retired from the National Trust where he worked with walls and trees and now spend his time repairing and renovating old walls around the Thornbury area. The walls need to be cleaned of loose material and any vegetation killed in preparation. We have treated the walls once and again when the weather improves. We will then provide materials and labour for him to repair as needed. (GH 5/25)

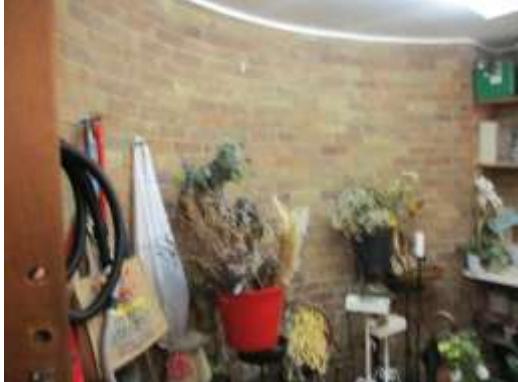
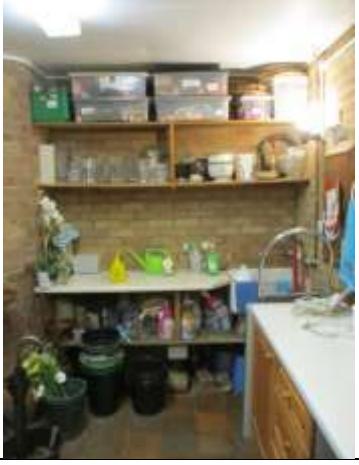
Location: C10

Flower Room near former church entrance			
Description:	Better & safer storage facilities needed but problem with curved wall. Seek advice from Flower volunteers for details of their requirements. Consider possible alternative storage for church cleaning equipment		
Urgency:	Medium term		
Possible cost?	Inhouse		
Progress?	Slight improvement to safety of the door threshold. Step was unnecessary narrow which encouraged tripping. The shelving in this room needs updating to make sure it remains safe for users. (GH 5/25)

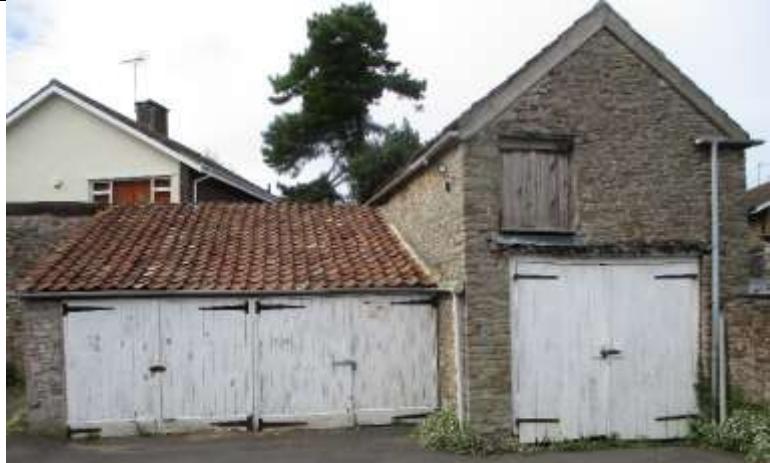
<p><i>Location: CP1</i></p> <p>Car Park area - Garage doors</p> <p>See CP4</p>

<i>Description:</i>	These doors – particularly Left and Centre - need replacing as doors and frames are both rotting. Make use of the Right hand side garage for a workshop and store of maintenance equipment. This will release the Left hand garage to reinstate as the Gardeners shed and workroom.
<i>Urgency:</i>	Short term (1-2 years)
<i>Possible cost?</i>	Inhouse
<i>Progress?</i>

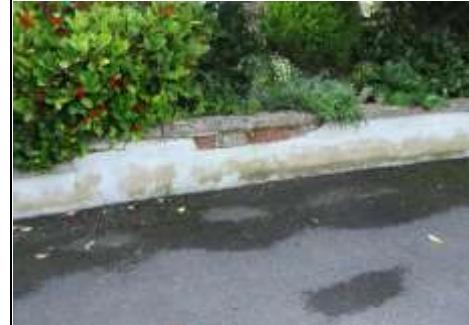
<p><i>Location: CP2</i></p> <p>Car Park boundary wall adjacent to garden.</p>

<i>Description:</i>	Rendering broken in parts probably due to cars hitting wall when parking. Wall sections need repair – remove rendering & insert drain holes.
<i>Urgency:</i>	Short term (2025-6)
<i>Possible cost?</i>	Inhouse
<i>Progress?</i>

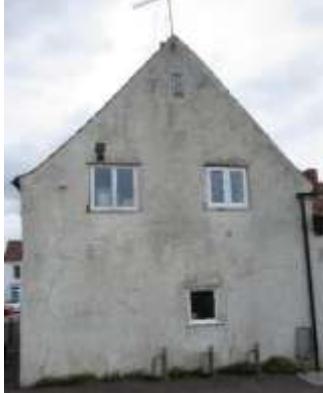
<p><i>Location: PH4</i></p> <p>Porch House complex – End wall of Porch House facing carpark</p>

<p><i>Description:</i></p>	<p>Rendering cracking in places and cement exposed around newly fitted windows. Cracks need repairing and wall needs repainting (along with other 2 walls) External repainting last undertaken in 2013 when labour provided by Leyhill Prison.</p>
<p><i>Urgency:</i></p>	<p>Medium term (2026-7)</p>
<p><i>Possible cost?</i></p>	<p>Contractor</p>
<p><i>Progress?</i></p>

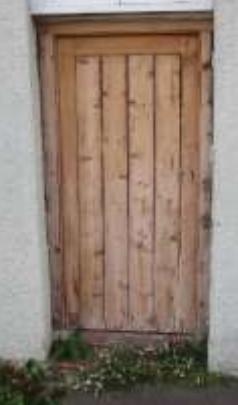
<p><i>Location: PH5</i></p> <p>Porch House complex – Door near entrance to Hall from carpark</p>

<p><i>Description:</i></p>	<p>This is a “dummy” door no longer used. Needs wood preservative treatment.</p>
<p><i>Urgency:</i></p>	<p>Short term (2025-6)</p>
<p><i>Possible cost?</i></p>	<p>Inhouse</p>
<p><i>Progress?</i></p>	<p>A working party was formed to remove, clean and paint the outside doors to Porch House and was a great success.</p>

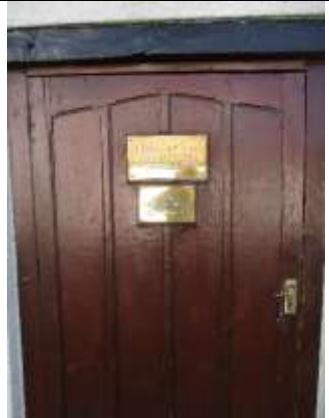
<p><i>Location:</i> PH6</p> <p>Porch House complex – Door to Hall & former Social Club from carpark</p>

<i>Description:</i>	Name plates on door need replacing. Suggest top plate states “Christ the King Porch House” and the lower plate “Hall entrance”
<i>Urgency:</i>	Short term (2025-6)
<i>Possible cost?</i>	Inhouse
<i>Progress?</i>	A working party was formed to remove, clean and paint the outside doors to Porch House and was a great success.

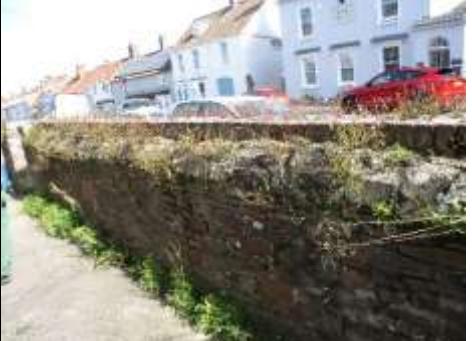
<p><i>Location:</i> PH7</p> <p>Porch House complex – Boundary wall along Castle Street</p>

<i>Description:</i>	Plant growth causing gaps in stonework and risk of stones falling. Growth to be removed and treated with strong weedkiller. Could be included in project C8 boundary wall.
<i>Urgency:</i>	Short term (2025-6)
<i>Possible cost?</i>	Inhouse & Contractor
<i>Progress?</i>

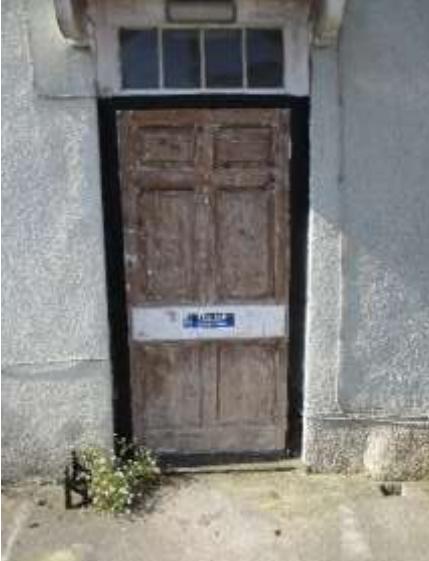
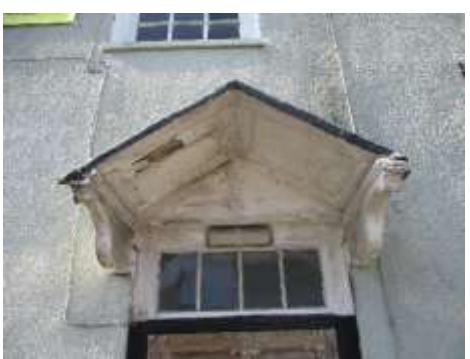
<p><i>Location: PH8</i></p> <p>Porch House complex – Door to Hall (not in regular use – fire door from Hall) & Doors to the porch</p>

<p><i>Description:</i></p>	<p>Hall doors need wood preservative covering & Porch doors need painting. Canopy over door needs renovation – possible replacement or upgrade. Suggest fitting of gate to improve the overall “look” of this side of the building but bear in mind fire escape requirements Suggest plaque naming “Porch House” and date built</p>
<p><i>Urgency:</i></p>	<p>Short term (2025-6)</p>
<p><i>Possible cost?</i></p>	<p>Inhouse</p>
<p><i>Progress?</i></p>	<p>A working party was formed to remove, clean and paint the outside doors to Porch House and was a great success.</p>

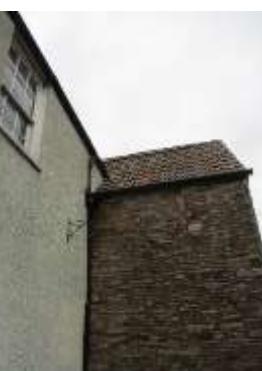
<p><i>Location: PH9</i></p> <p>Porch House complex – Guttering to left of Porch House Castle St entrance</p>

<p><i>Description:</i></p>	<p>Cast-iron guttering & pipework seems in poor condition & may be causing damp on inside Hall wall. Needs investigating & possible replacement of all cast-iron</p>
<p><i>Urgency:</i></p>	<p>Short term (2025-6)</p>
<p><i>Possible cost?</i></p>	<p>Contractor</p>
<p><i>Progress?</i></p>

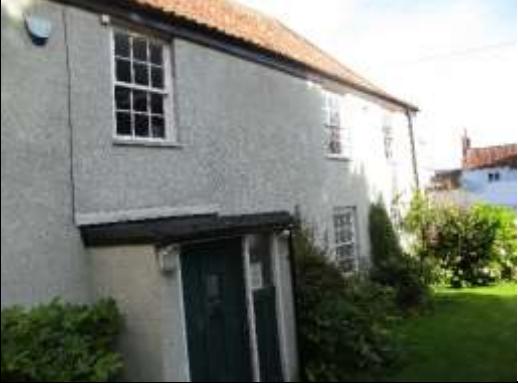
<i>Location:</i> PH10	Porch House complex – Windows on Side wall & entrance to Porch House

<i>Description:</i>	Windows along this wall in poor condition and need replacing. As the building is listed this may require specific materials/design	
<i>Urgency:</i>	Medium term (2027-8)	
<i>Possible cost?</i>	Contractor	
<i>Progress?</i>	Contractor repaired 9 of the 11 sash windows in August 2025. Two were inaccessible above the porch and in the lighting room used by Octopus drama group. They will make these available soon and the craftsman will return to finish the work.

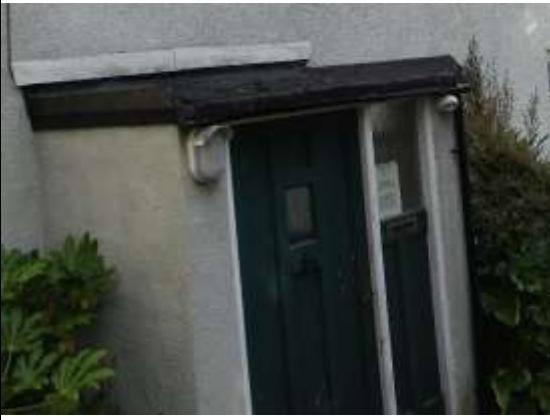
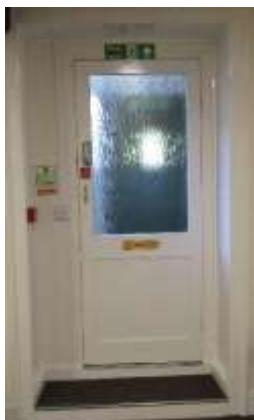
<i>Location:</i> PH11	Porch House complex – Side entrance to Porch House

<i>Description:</i>	Door, frame and side window all in poor condition. All need replacement in conjunction with inner door as both are fire doors and should open outwards. Inner door needs to be more secure.	
<i>Urgency:</i>	Medium term (2027-8)	
<i>Possible cost?</i>	Contractor	
<i>Progress?</i>

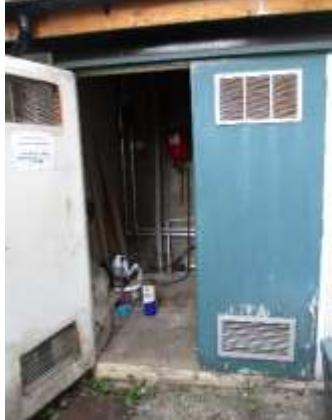
<p>Location: PH12</p> <p>Boiler house doors</p>

Description:	Doors in poor condition. Need renovation.
Urgency:	Medium term (2027-8)
Possible cost?	Contractor
Progress?

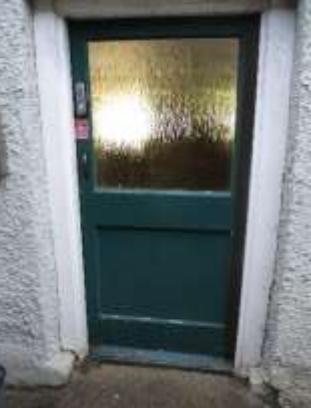
<p>Location: PH13</p> <p>Door to Kitchen</p>

Description:	This is a fire door and should hinge on the left-hand side and open outwards. Needs to be more secure as used as main entrance to Porch House.
Urgency:	Medium term (2027-8)
Possible cost?	Inhouse
Progress?	The door hinges were examined as the door was flexing and not closing properly. The hinges were okay but the bottom of the door is rotten. The keypad entry lock has been replaced as the old one was failing. (GH 5/25)

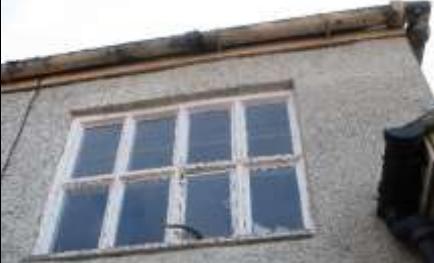
Location: PH14

Window to end office	
Description:	Needs renovation. All windows that are not due for replacement need to be refreshed and repainted.
Urgency:	Medium term (2027-8)
Possible cost?	
Possible cost?	Contractor to renovate all windows
Progress?

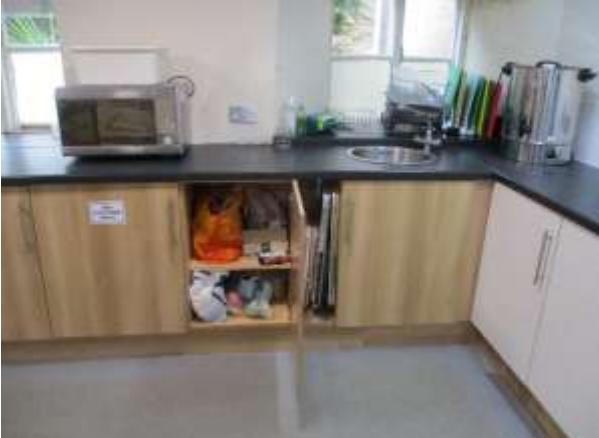
Location: PH15

Description:	Request for installation of dishwasher. Probable location near small sink to make use of power supply & water supply & waste
Urgency:	Short term (2025-6)
Possible cost?	Contractor
Progress?

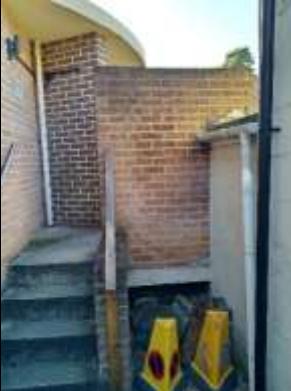
<i>Location:</i> PH18

Porch House complex – drop wall height to create wider access to kitchen from church		
<i>Description:</i>		Drop height of wall and adjoining roof area to improve access to kitchen.
<i>Urgency:</i>	Medium term (2027-8)	
<i>Possible cost?</i>		Contractor
<i>Progress?</i>	The current gardeners' shed which used to be the outside beer store for the club, can be demolished to make a level path through to the kitchen door. The wall with the handrail on the left hand approach to the church can then be reduced in height and capped to improve visibility and overall look. (GH 5/25) Former gardeners' shed removed & pathway cleared for access to kitchen. (GH 11/25)

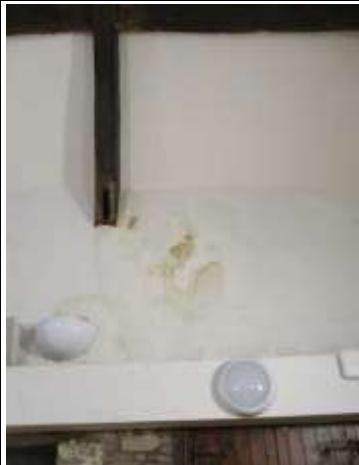
<p><i>Location: H1</i></p> <p>Hall – internal wall – area near roof joist</p>

<p><i>Description:</i></p>	<p>Staining on part of ceiling suggests there is water ingress. Perhaps from loose tiles or blocked guttering? Needs investigation and repair particularly as near a roof joist.</p> <p>See note regarding cast-iron pipework & guttering Porch House entrance (PH9)</p> <p>Opportunity to repaint the upper walls & boxing around lighting cables?</p>	
<p><i>Urgency:</i></p>	<p>Medium term (2027-8)</p>	
<p><i>Possible cost?</i></p>		<p>Inhouse & contractor depending upon nature of work required</p>
<p><i>Progress?</i></p>

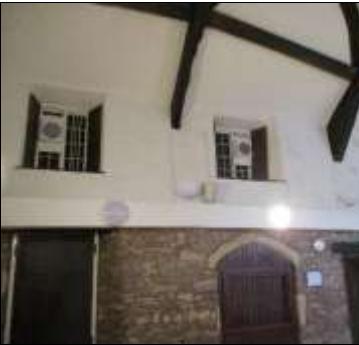
<p><i>Location: H2</i></p> <p>Hall lighting – Uplighters</p>

<p><i>Description:</i></p>	<p>The uplighters around the hall no longer work.</p> <p>Are they needed? Should they be removed or replaced?</p>	
<p><i>Urgency:</i></p>	<p>Medium term (2027-8)</p>	
<p><i>Possible cost?</i></p>		<p>Inhouse</p>
<p><i>Progress?</i></p>		<p>The problem with the uplighters was the amount of power they consumed using mercury vapour technology. These bulbs were removed and the ignitor circuits bypassed. In their place high power LED bulbs were installed but have proved unreliable. Only one light now has a working bulb. Because of the improvements to the hall pelmet lighting by Fr George the lack of uplighters has not been a problem if noticed at all.(GH 5/25)</p>

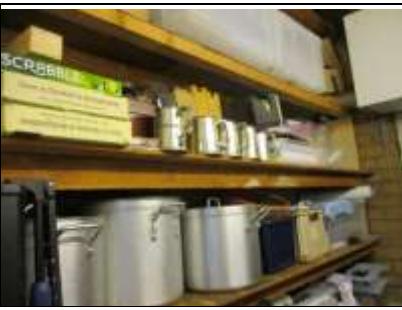
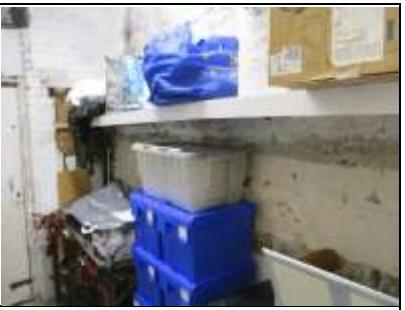
<p><i>Location: H3</i></p> <p>Lounge – former beer cellar room</p>

<p><i>Description:</i></p>	<p>Now used as a general storage area but needs:</p> <ul style="list-style-type: none"> repair to corroded water pipe disposal of all unnecessary items & equipment (inc air conditioning unit & compressor above on roof) check on electrical consumer unit painting & freshening up fitting of storage shelving 	
<p><i>Urgency:</i></p>	<p>Medium term (2027-8) except for urgent repair to corroded water pipe</p>	
<p><i>Possible cost?</i></p>		<p>Contractor</p>
<p><i>Progress?</i></p>	<p>Taking advice from users of the cellar on what they want to use the space for and what equipment they do and don't want to keep. Once the area is clear the water pipe can be replaced. NB. The stopcock on the rising main into the whole complex is seized and weeping water. Its particular problem is that it's connected to the lead pipe entering the building. Maybe 15 years since it was last used. Our plumber/heating engineer has it on his list. (GH 5/25)</p> <p>EICR testing to be done</p>
