2026 Holy Cross Church Building Quinquennial Review

SUMMARY OF JOBS

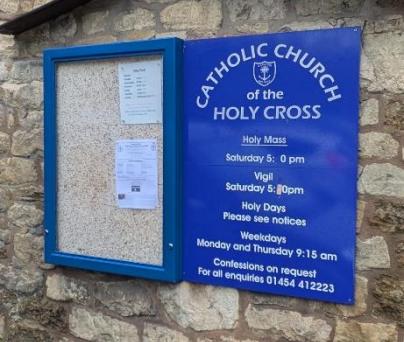
| E02 Notice Board | |

| <i>Description:</i> | Board needs replacing and text updating. |

| <i>Progress?</i> | Elaine Godfrey investigating |

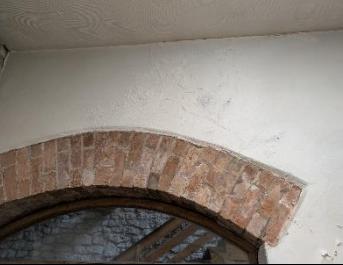
| C02 Sacristy | |

| <i>Description:</i> | Damp recorded. decorate |

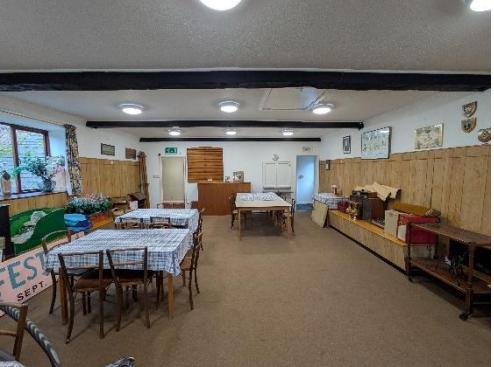
| Location: Upper Room U01 Upper Room floor | |

| Description: | Flooring needs review & possible lifting & replacing |
